**Flood Control Project Maintenance
Levee Inspections**
LMA District Cover Sheet
Spring 2019 Levee Inspection Results

Reclamation District No. 0536 Egbert

Spring 2019 Levee Inspection Results

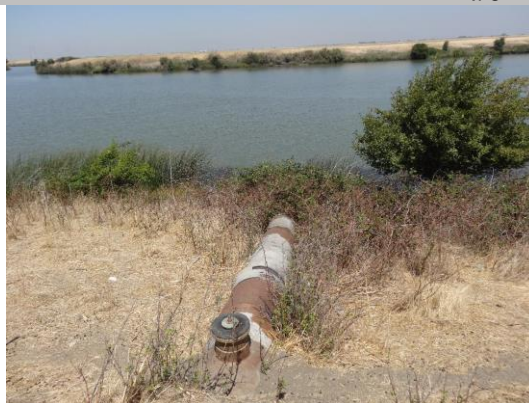
Photo 1 of 3 : UCIP_SP_2019_49317_34579.jpg

LM Start	3.95	Rating **	M	Issue No.	63 (cont)
LM End	3.95	Issue Type +	En	Location *

WS view: exposed steel pipe with siphon breaker on levee slope.

Comment Code						
Inspector Comment						
FS_ID:49317 DS_ID:22719 EP_NO: 2131 Repair Type: Non-Urgent Crossing Status: Found UCIP Comments: 06/01/2016 New pump recently installed. Flapgate not visible though not required under condition of Permit No. 2131. No positive closure device found, which, if missing, is a violation of Condition 8 of Permit No. 2131. Need a name change permit for new owner RD0536. Siphon breaker missing cover.08/13/2013 Pump is missing at the time of inspection. May be taken out for repair.Flapp gate on waterward end not found/visible as pipe was submerged into water.Pipe itself is a walkway with steel handrail. FIELD_STRUCT_DESC: 20-inch drainage discharge pipe of an unknown material through the levee, 1.5 feet below the crown. Pump, which was replaced recently, is on a steel platform in the drainage ditch on the landside (LS) toe. Siphon breaker on the waterside (WS) slope. Pipe is exposed on both slopes, but only found on the WS in 2016. Walkway over the pipe on the LS leads to the pump platform. Pipe and pump are now used by Reclamation District No. 536 [RD0536], per district president David Hearn. (Plans for construction of a 20-horsepower drainage pump installation and a 20-inch discharge pipe through the levee authorized under Permit No. 2131, 1955 - California Packing Corporation). [Additional Reference(s): DWR Levee Log, 1992]. FS Date: 6/1/2016

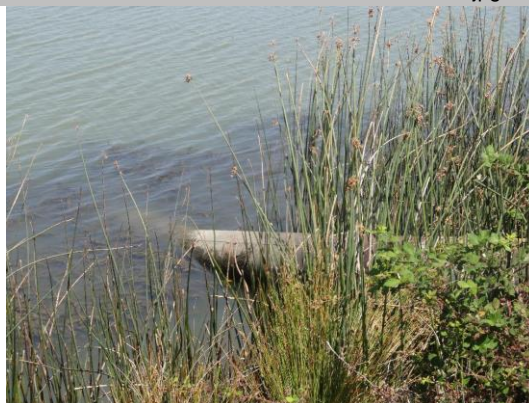
Photo 2 of 3 : UCIP_SP_2019_49317_34578.jpg

WS view: steel pipe submerged into water in the stream.

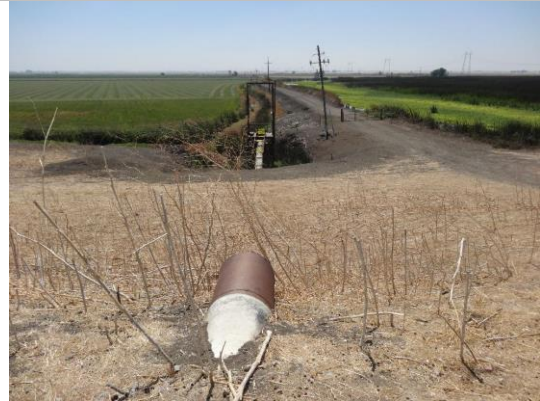
Photo 3 of 3 : UCIP_SP_2019_49317_34577.jpg

LS view: exposed steel pipe on levee slope and pump deck in drainage ditch.

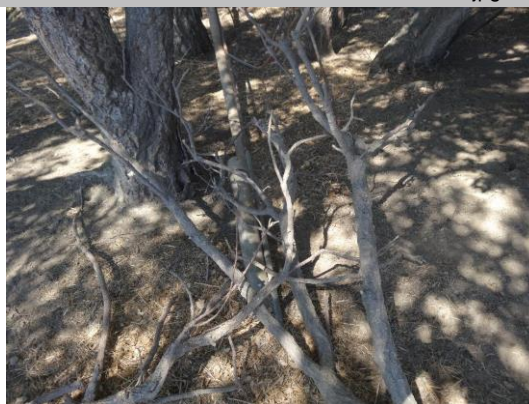
Photo 2 of 3 : UCIP_SP_2019_49318_34604.jpg

Comment Code					
Inspector Comment					
FS_ID:49318 DS_ID:22720 EP_NO: 10116 Repair Type: Non-Urgent Crossing Status: Found UCIP Comments: 06/01/2016 Pipe is an abandoned crossing per conversation with district president David Hearn.Pipe seems to be abandoned.Catwalk and pumphouse on riverside not found. It is not clear whether the pipe pass through the levee or not. Needs more info from LMA/DWR Inspector. FIELD_STRUCT_DESC: 3-inch galvanized irrigation discharge pipe through the levee, 4 feet below the crown. Catwalk and pump house on the waterside (WS). Concrete saddle and water tank on the WS slope. (Retention of a 3.5-inch pipe through the levee, 4 feet below the crown, concrete saddle, and water tank on the WS slope authorized under Automatic Board Order (ABO) issued as Permit No. 10116, 1974 - Marion Sanchez Farms). [Additional Reference(s): DWR Levee Log, 1992. USACE Sacramento O&M Manual 106, May 1953, (Station 33+16 ""R""), invert elevation 19 feet]. FS Date: 8/13/2013

WS view: exposed pipes on levee shoulder.

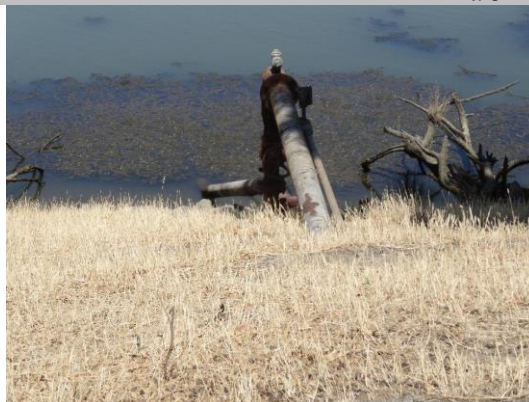
Photo 2 of 2 : UCIP_SP_2019_49319_35123.jpg

Comment Code					
Inspector Comment					
FS_ID:49319 DS_ID:24664 EP_NO: N/A Repair Type: Non-Urgent Crossing Status: Found UCIP Comments: 06/01/2016 According to district president David Hearn, landowner is Silva and crossing is abandoned.08/13/2013:Field discovered pipe crossing.Needs more information from LMA/DWR Inspector. Also needs more detailed inspection. FIELD_STRUCT_DESC: *ABANDONED* Approximately 6-inch steel irrigation discharge pipe and an electrical conduit through the levee, at an unknown depth. Slant pump in a steel support on the channel bank. Gate valve on the pipe. No pipes and appurtenances on the landside (LS). This crossing was field discovered. FS Date: 8/13/2013

WS view: closer view of pipe and pump on channel bank.

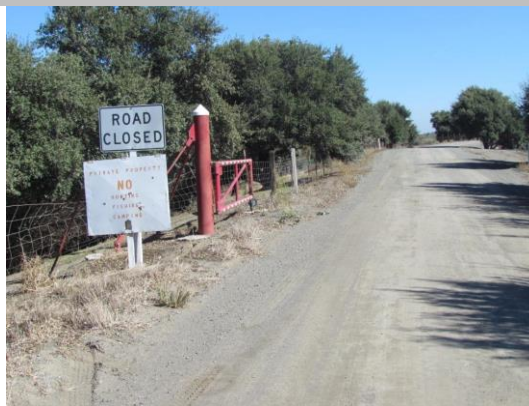
Photo 1 of 2 : SP_2019_RD0536_208_11_20190311_00001.jpg

LM Start	5.34	Rating **	U	Issue No.	11
LM End	5.34	Issue Type +	En	Location *	CR
Category	Earthen Levee			GPS Latitude/Longitude	
				Start	End
Item	Encroachments			38.245644 °	38.245644 °
				-121.701945 °	-121.701945 °
DWR ID	DWR_RD0536_01_s_2013_11				
Comment Code					
FE : Fence					
Inspector Comment					
The District said that the property owner had this gate and barricade installed by the County.

RD 536 Unit 1 levee mile 5.34 waterside shoulder.

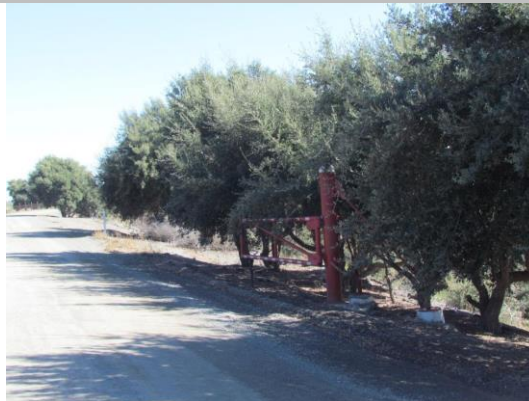
Photo 2 of 2 : SP_2019_RD0536_208_11_20190311_00002.jpg

This gate rest and gate on the landside of the levee shoulder.

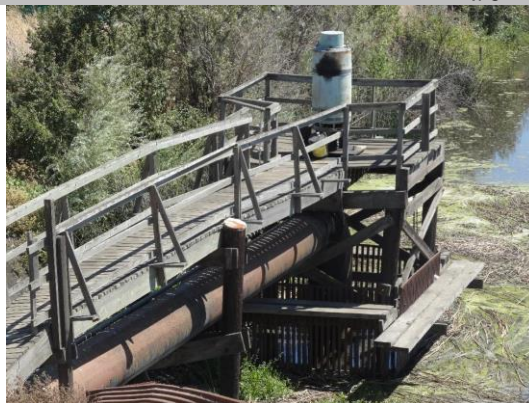
Photo 3 of 3 : UCIP_SP_2019_20563_34644.jpg

Comment Code						
Inspector Comment						
FS_ID:20563 DS_ID:22722 EP_NO: 7208 Repair Type: Non-Urgent Crossing Status: Found UCIP Comments: - siphon breaker needs cover/protection.- service pole on landside of the levee. FIELD_STRUCT_DESC: 30-inch steel drainage discharge pipe through the levee, 5.7 feet below the crown. Pump in a piling structure in a drainage ditch on the landside (LS). Siphon breaker on the waterside (WS) shoulder. (Plans to install a drainage pumping plant and 35 feet of 30-inch pipe through the levee authorized under Permit No. 7208, 1970 - Reclamation District No. 536 [RD0536]). [Additional Reference(s): DWR Levee Log, 1992]. FS Date: 8/13/2013

LS view: pipe under the wooden walkway and pump on wooden platform in drain ditch.

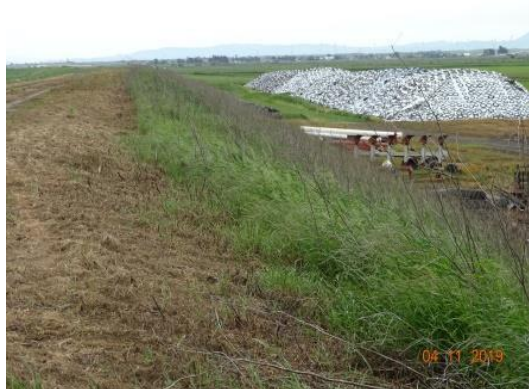
Photo 1 of 1 : SP_2019_RD0536_209_7_20190412_00020.jpg

LM Start	0.12	Rating **	U	Issue No.	7
LM End	2.15	Issue Type +	Ma	Location *	LS
Category	Earthen Levee			GPS Latitude/Longitude	
				Start	End
Item	Vegetation			38.243804 °	38.214737 °
				-121.696941 °	-121.694040 °
DWR ID	DWR_RD0536_02_s_2019_7				
Comment Code					
V1 : Control annual grass and weeds on the levee slopes and easements.					
Inspector Comment					
Maintain the annual vegetation.

View looking downstream at annual vegetation on the landside slope (Spring 2019).

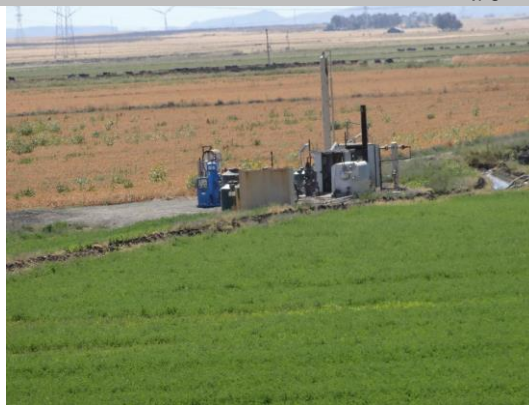
Photo 3 of 3 : UCIP_SP_2019_20664_34744.jpg

LM Start	1.47	Rating **	M	Issue No.	27 (cont)	
LM End	1.47	Issue Type +	En	Location *		
Category	Supplemental			GPS Latitude/Longitude		
				Start	End	
Item	DWR UCIP Field Study			38.224423 °	38.224423 °	
				-121.697049 °	-121.697049 °	
DWR ID	22732					
Comment Code						
Inspector Comment						
FS_ID:20664 DS_ID:22732 EP_NO: 17829 Repair Type: Non-Urgent Crossing Status: Indicator Found UCIP Comments: Indicator is found only on WS. The indicator is different than standard indicator. Needs more info from LMA/DWR Inspector. FIELD_STRUCT_DESC: 3.5-inch welded steel natural gas pipeline under the levee, 44 feet below the crown. (Plans to install a 3.5-inch welded steel natural gas pipeline bored under the levee authorized under Permit No. 17829, 2004 - Towne Exploration Company). FS Date: 8/13/2013

WS view: natural gas extraction plant near levee on the field.

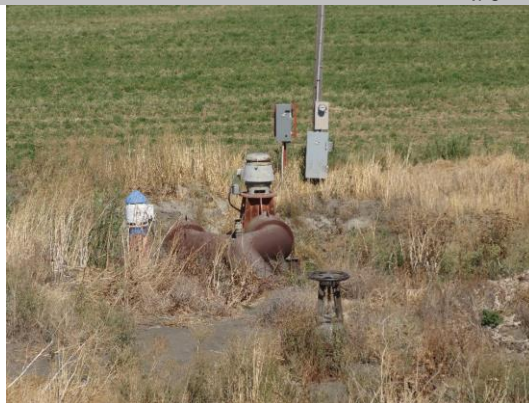
Photo 1 of 2 : UCIP_SP_2019_20647_34731.jpg

LM Start	2.50	Rating **	M	Issue No.	28
LM End	2.50	Issue Type +	En	Location *	
Category	Supplemental			GPS Latitude/Longitude	
				Start	End
Item	DWR UCIP Field Study			38.210063 °	38.210063 °
				-121.691768 °	-121.691768 °
DWR ID	24025				
Comment Code					
Inspector Comment					
FS_ID:20647 DS_ID:24025 EP_NO: N/A Repair Type: Non-Urgent Crossing Status: Found UCIP Comments: Needs more info from LMA/DWR Inspector. Pump and pipe looks new. FIELD_STRUCT_DESC: 12-inch steel irrigation discharge pipe with vertical pump on the drainage ditch. No other details available. This crossing was field discovered. FS Date: 8/13/2013

WS view: overview of pipe and pump (left). Big pump and appurtenances (right) for 24" steel pipe.

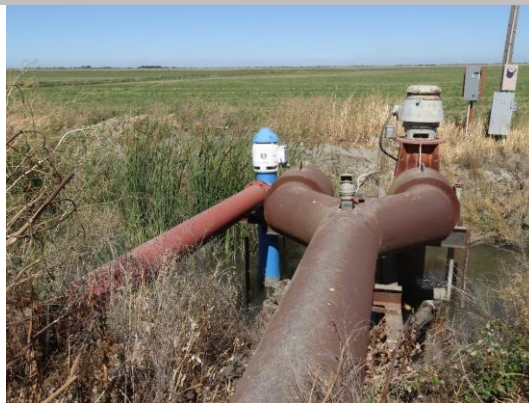
Photo 2 of 2 : UCIP_SP_2019_20647_34730.jpg

WS view: closer view of pipe and pump (left). Big pump and appurtenances (right) for 24" steel pipe.

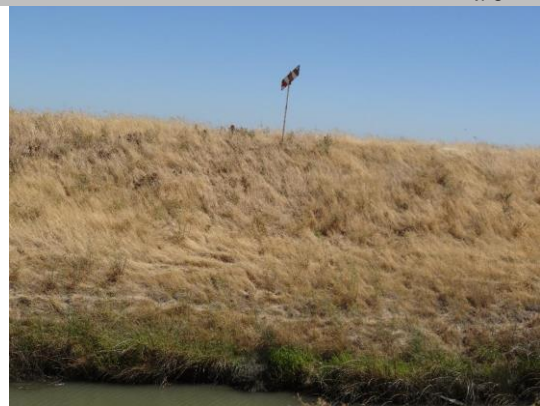
Photo 1 of 2 : UCIP_SP_2019_41845_34765.jpg

LM Start	4.14	Rating **	M	Issue No.	29	
LM End	4.14	Issue Type +	En	Location *		
Category	Supplemental			GPS Latitude/Longitude		
				Start	End	
Item	DWR UCIP Field Study			38.195875 °	38.195875 °	
				-121.695177 °	-121.695177 °	
DWR ID	22731					
Comment Code						
Inspector Comment						
FS_ID:41845						
DS_ID:22731						
EP_NO: 1217						
Repair Type: Non-Urgent						
Crossing Status: Indicator Found						
UCIP Comments: Gasline needs markers on both slopes. Existing markers in disrepair.						
FIELD_STRUCT_DESC: 8.625-inch natural gas pipeline of an unknown material through the levee, at an unknown depth. (Plans for installing an 8.625-inch natural gas pipeline crossing authorized under Permit No. 1217, 1947 - Pacific Gas and Electric Company [PG&E]). [Additional Reference(s): DWR Levee Log, 1992].						
FS Date: 8/13/2013

WS view: gasline indicator across the channel.

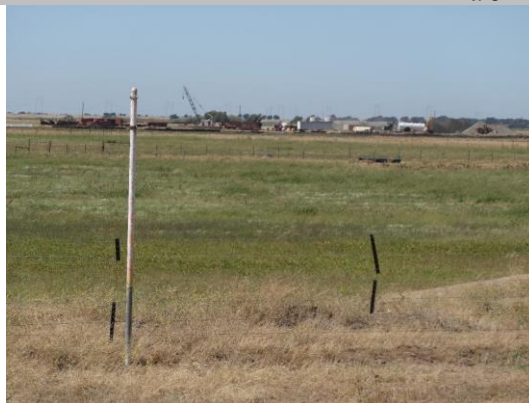
Photo 2 of 2 : UCIP_SP_2019_41845_34764.jpg

LM Start	4.14	Rating **	M	Issue No.	29 (cont)	
LM End	4.14	Issue Type +	En	Location *		
Category	Supplemental			GPS Latitude/Longitude		
				Start	End	
Item	DWR UCIP Field Study			38.195875 °	38.195875 °	
				-121.695177 °	-121.695177 °	
DWR ID	22731					
Comment Code						
Inspector Comment						
FS_ID:41845 DS_ID:22731 EP_NO: 1217 Repair Type: Non-Urgent Crossing Status: Indicator Found UCIP Comments: Gasline needs markers on both slopes. Existing markers in disrepair. FIELD_STRUCT_DESC: 8.625-inch natural gas pipeline of an unknown material through the levee, at an unknown depth. (Plans for installing an 8.625-inch natural gas pipeline crossing authorized under Permit No. 1217, 1947 - Pacific Gas and Electric Company [PG&E]). [Additional Reference(s): DWR Levee Log, 1992]. FS Date: 8/13/2013

LS view: gasline indicator on levee toe.

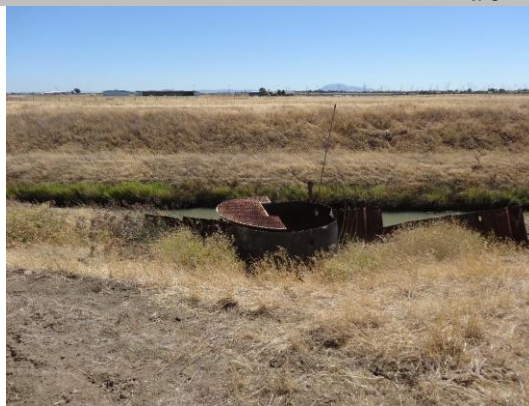
Photo 1 of 3 : UCIP_SP_2019_46813_34768.jpg

LM Start	4.36	Rating **	M	Issue No.	30
LM End	4.36	Issue Type +	En	Location *	
Category	Supplemental			GPS Latitude/Longitude	
				Start	End
Item	DWR UCIP Field Study			38.196429 °	38.196429 °
				-121.698962 °	-121.698962 °
DWR ID	22735				
Comment Code					
Inspector Comment					
FS_ID:46813 DS_ID:22735 EP_NO: N/A Repair Type: Non-Urgent Crossing Status: Found UCIP Comments: Recommend owner contact CVFPB to provide updated owner info and obtain necessary permit for this crossing. FIELD_STRUCT_DESC: 18-inch steel drainage pipe through the levee, at an unknown depth. Steel standpipe on each side of the levee. Temporary canvas about 2 inches below the crown. Per 2015 Inspection Report provided by Herman Phillips, a diesel motor was found on the waterside (WS), and the owner is Mr. Page Baldwin. This crossing was field discovered. FS Date: 8/13/2013

WS view: steel standpipe on levee slope.

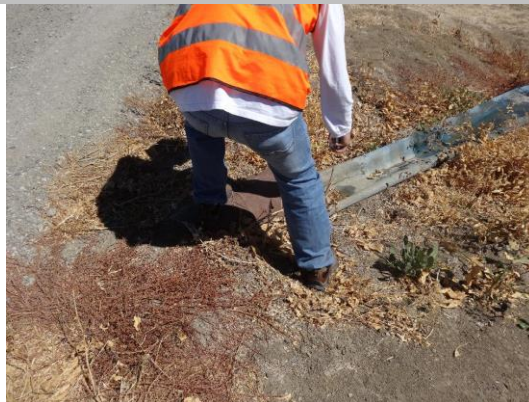
Photo 3 of 3 : UCIP_SP_2019_46813_34766.jpg

WS view: steel pipe on levee shoulder at 2-inch below the crown.
